4- UNITED STATES DEPARTMENT OF AGRICULTURE
SOIL CONSERVATION SERVICE RIO GRANDE DISTRICT
REGION EIGHT - RIO GRANDE SURVEY

REPORT ON
SURVEYS, EXAMINATIONS, AND INVESTIGATIONS
MADE NEAR SAN MARCIAL, NEW MEXICO
DURING 1936, 1937, and 1938

Subject: Siltation Conditions in and near
San Marcial, New Mexico, - 1936-38

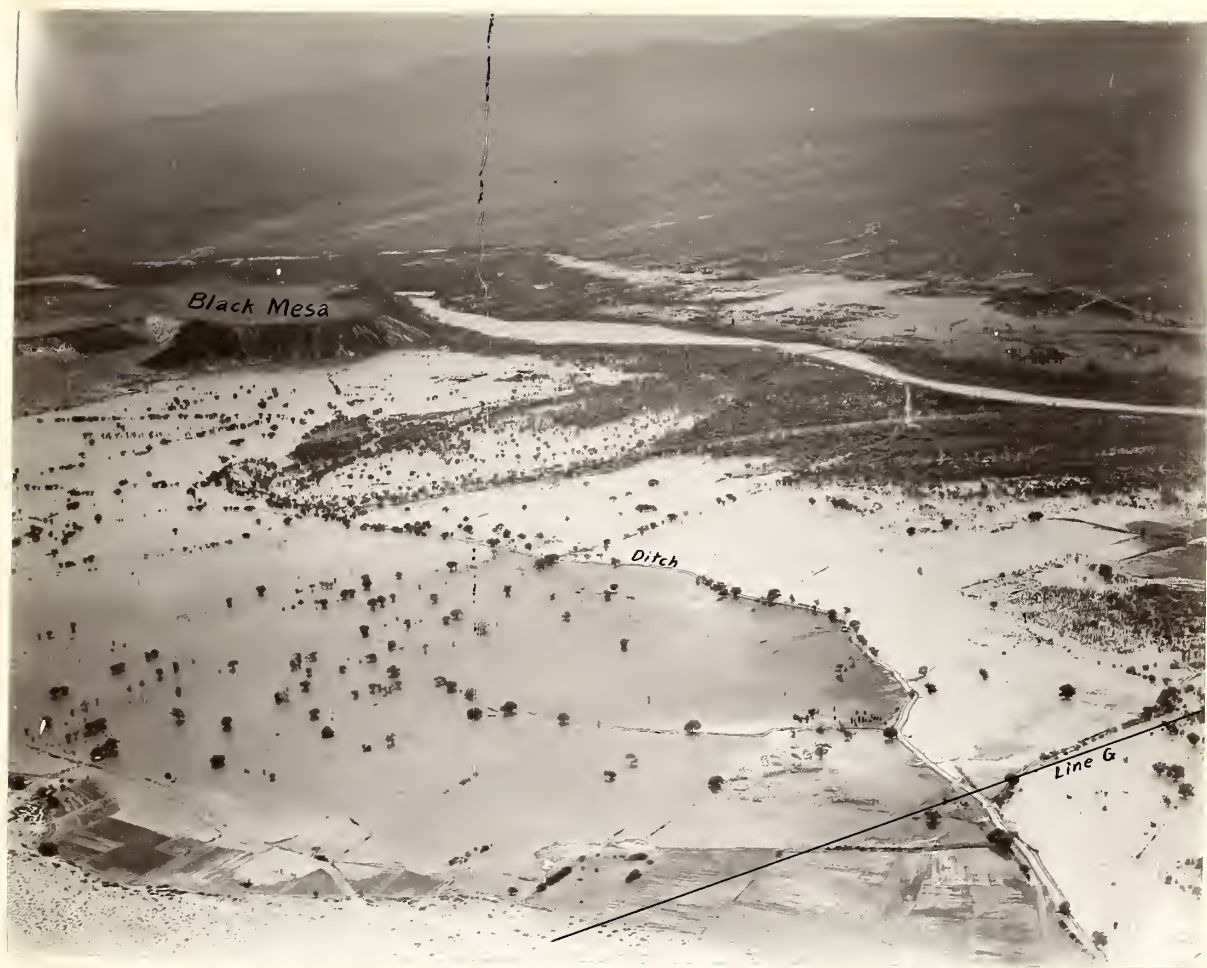
Central portion of inundated area at Val Verde. Looking south from directly above the town.

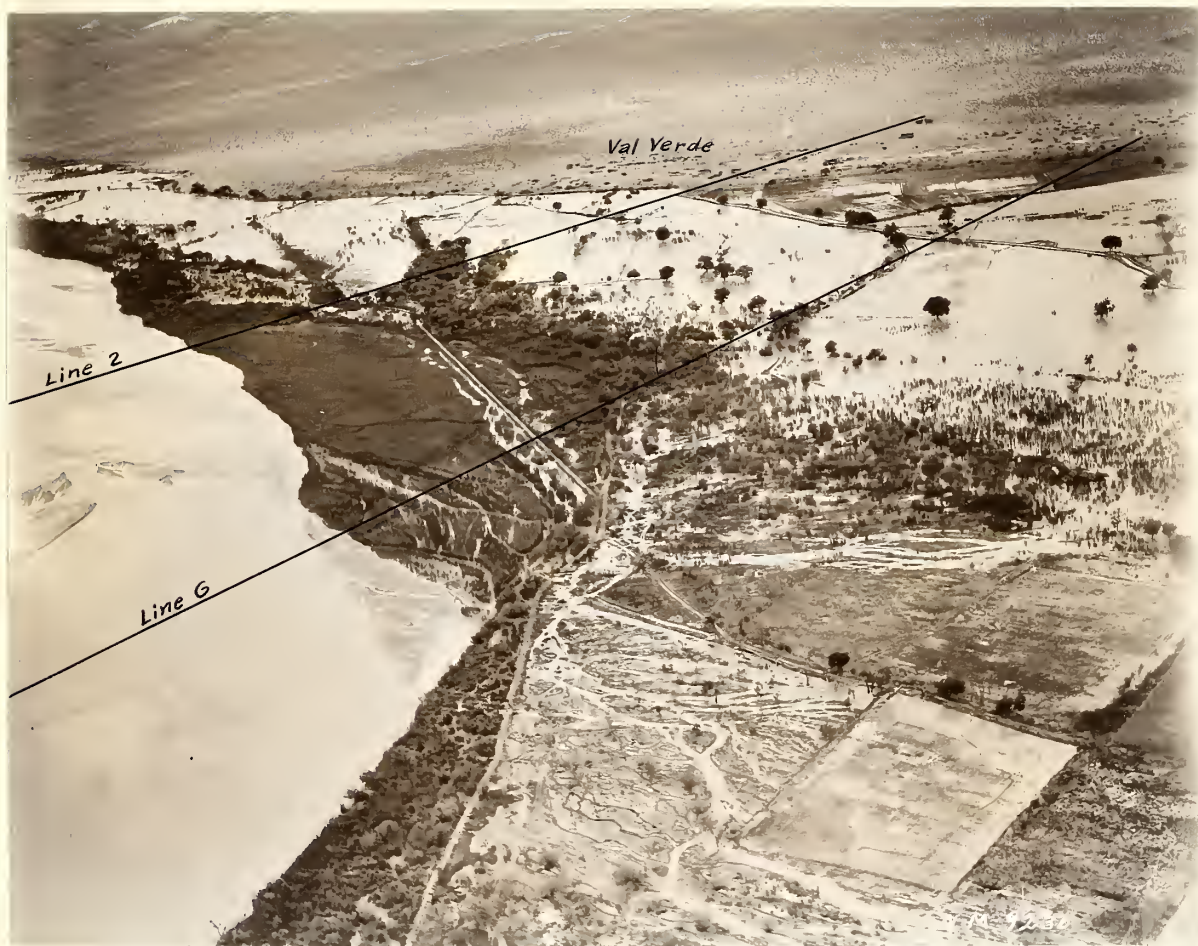
Flooded area south of Val Verde. Shows the high water flowing into the area through breaks in the dikes along the center of the picture. Looking northeast from just north of the highway bridge.

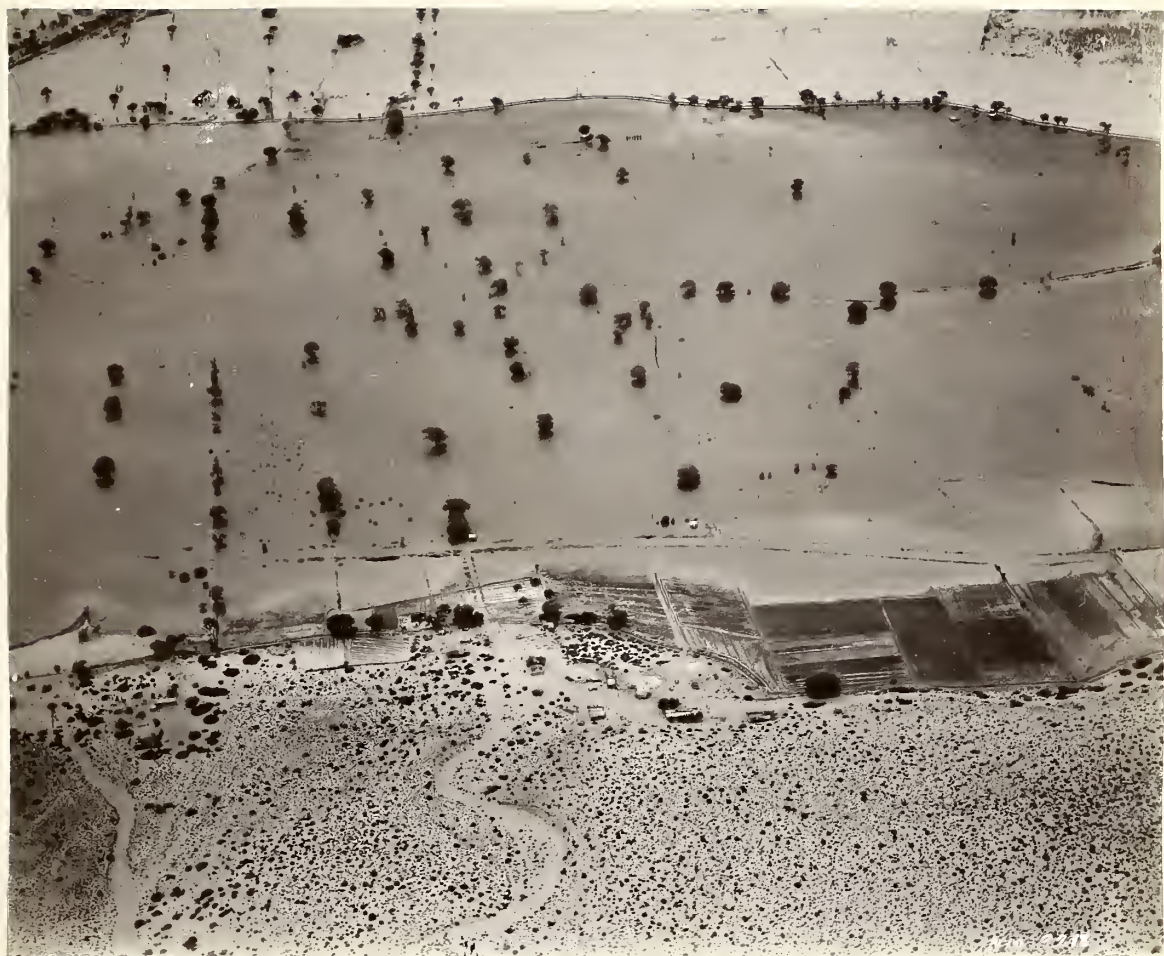
Inundated agricultural lands below Val Verde. Showing farm houses 1600 feet northerly from Triangulation Station Flor Amarilla.

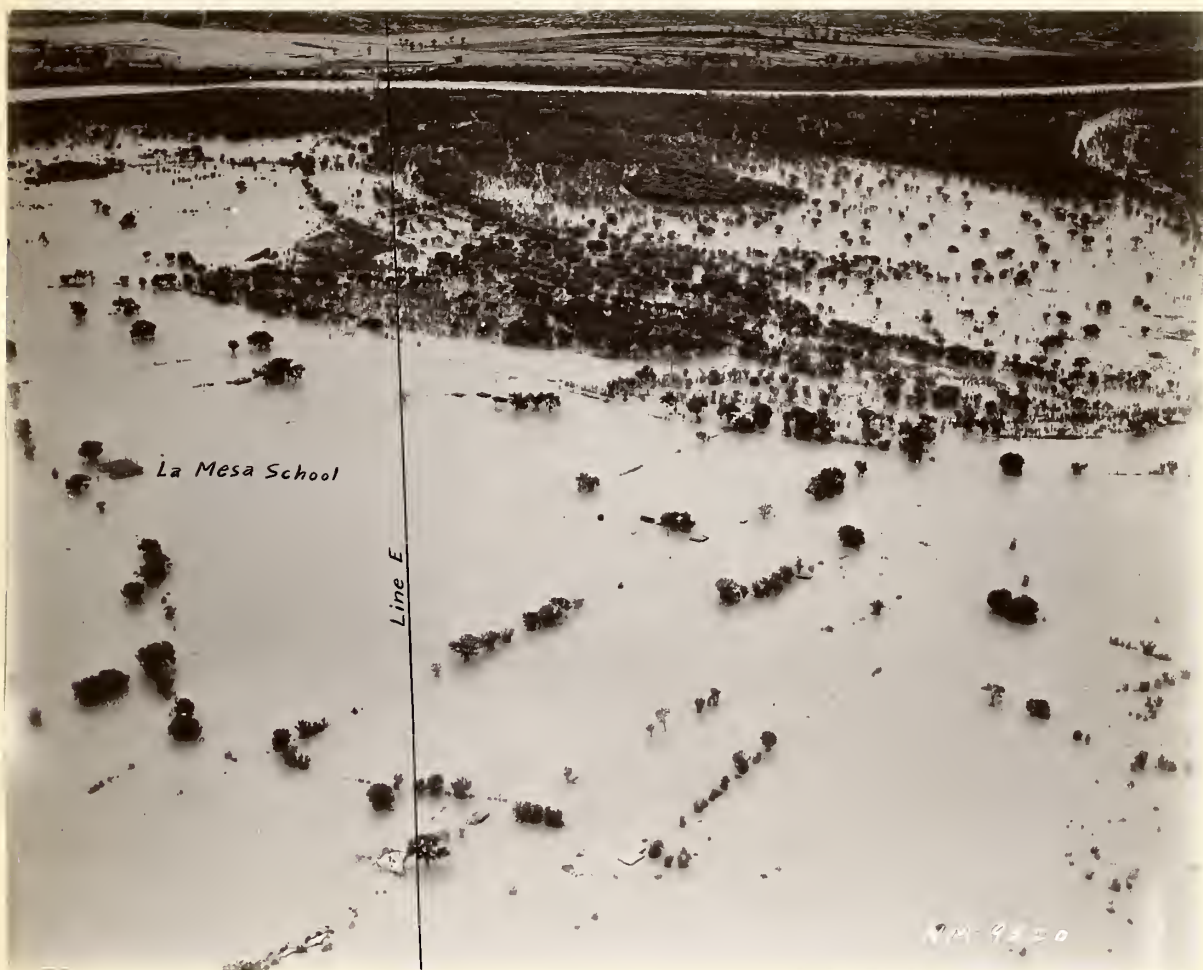
Inundated agricultural land and dwellings near La Mesa. Highway bridge in left background. Looking west.

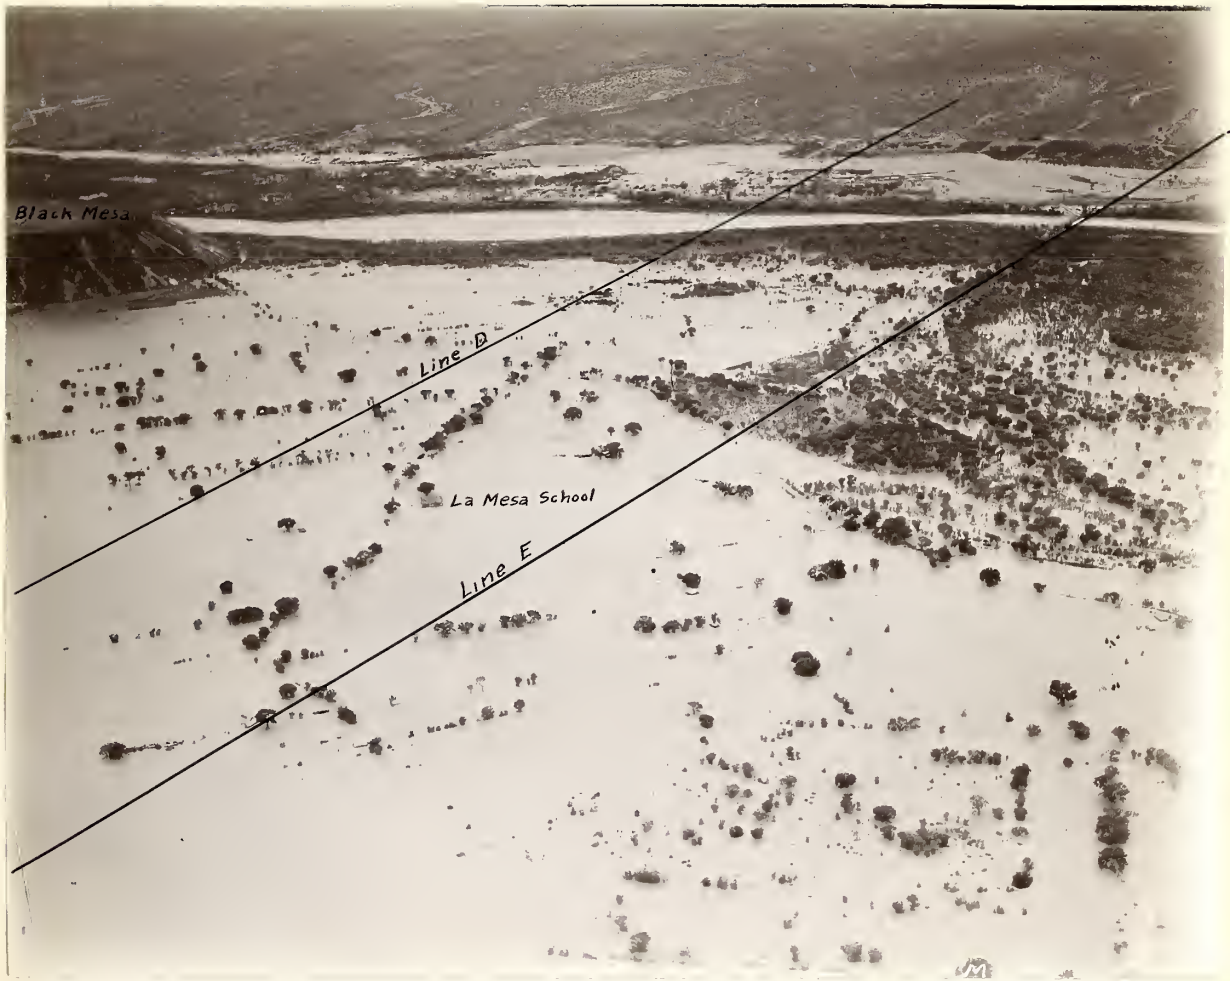
Inundated agricultural land and dwellings between Val Verde and La Mesa.
Looking westward.

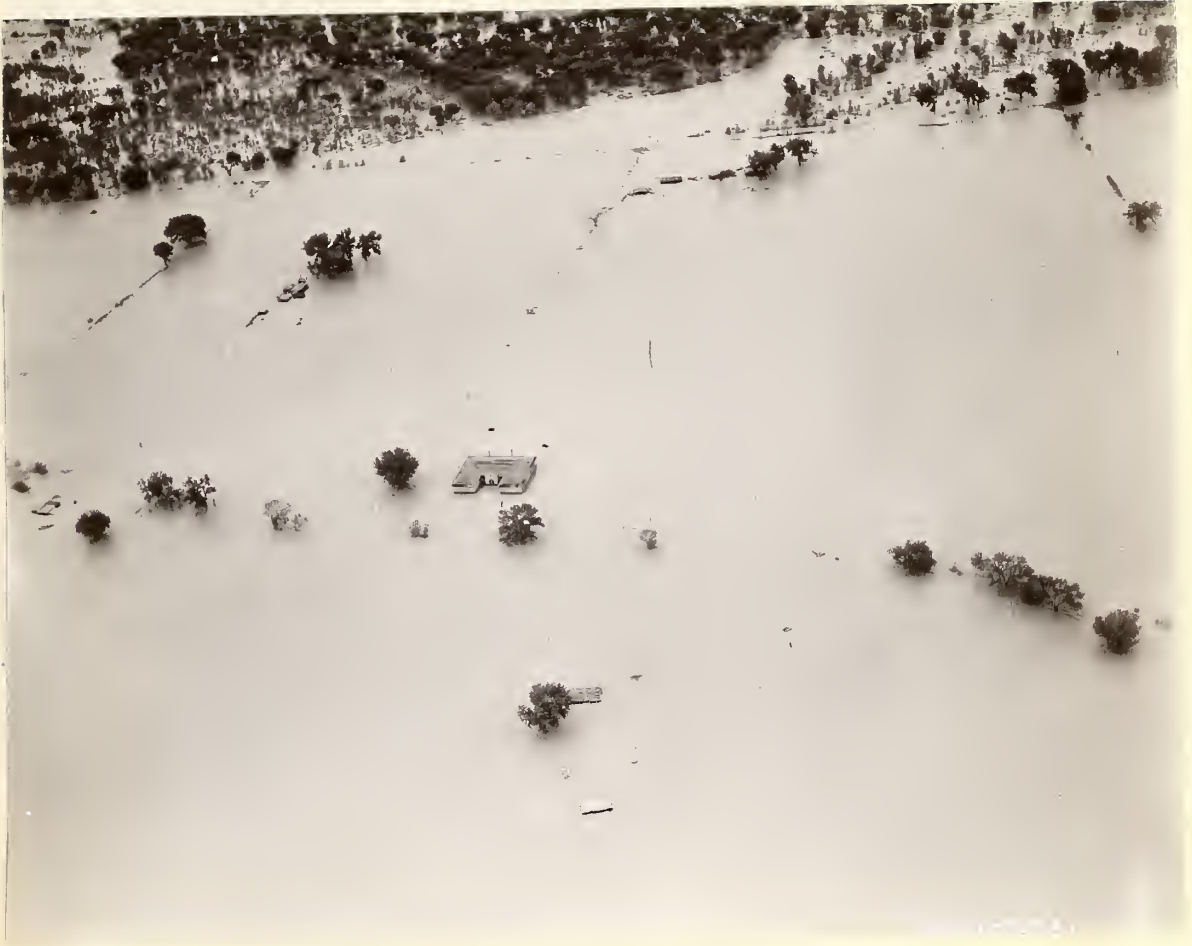
Lower end of Val Verde Valley. Flowing water at upper right. Still water in foreground. La Mesa schoolhouse near center.

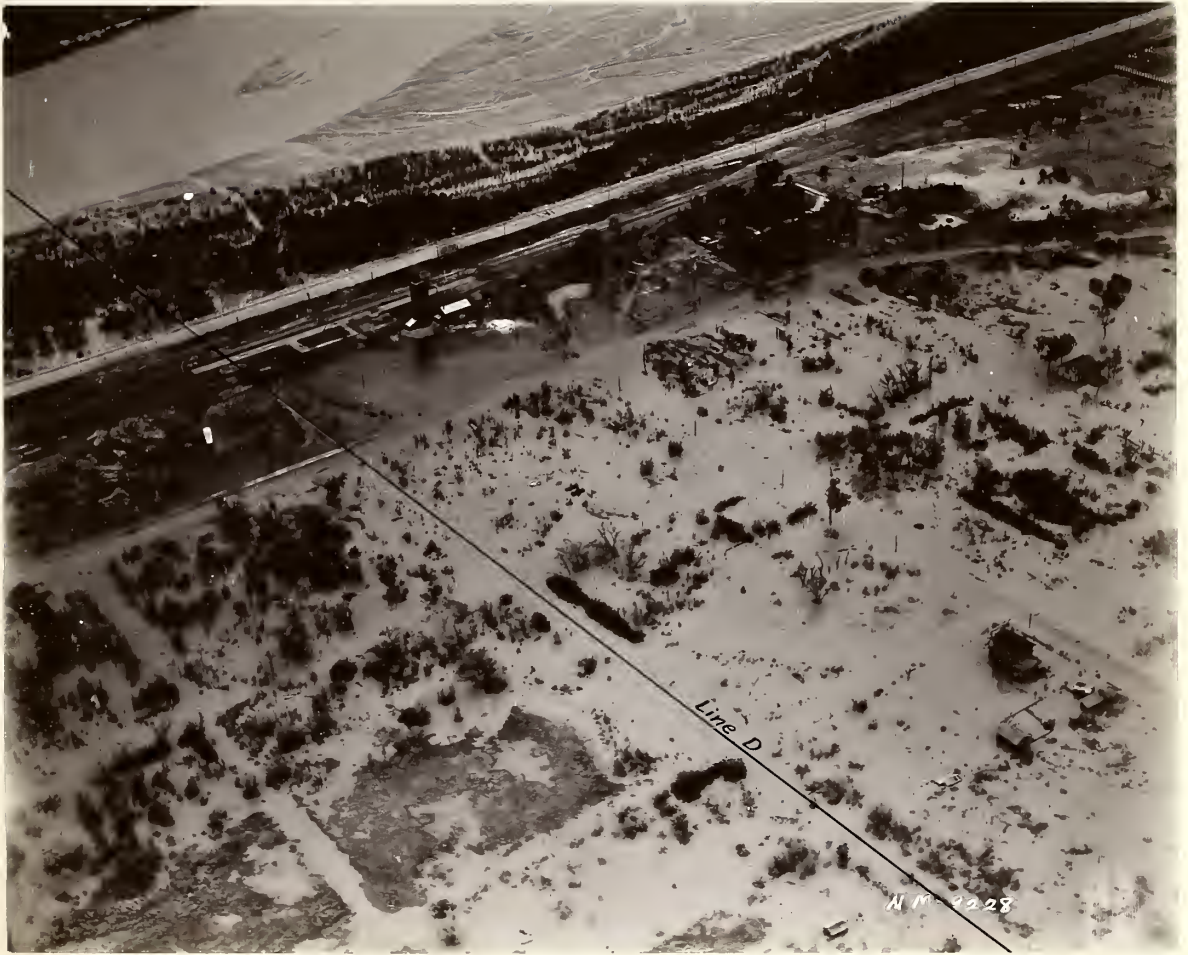
San Marcial Railway Station, section headquarters, and dwellings surrounded by water. Looking southeast from near San Marcial.

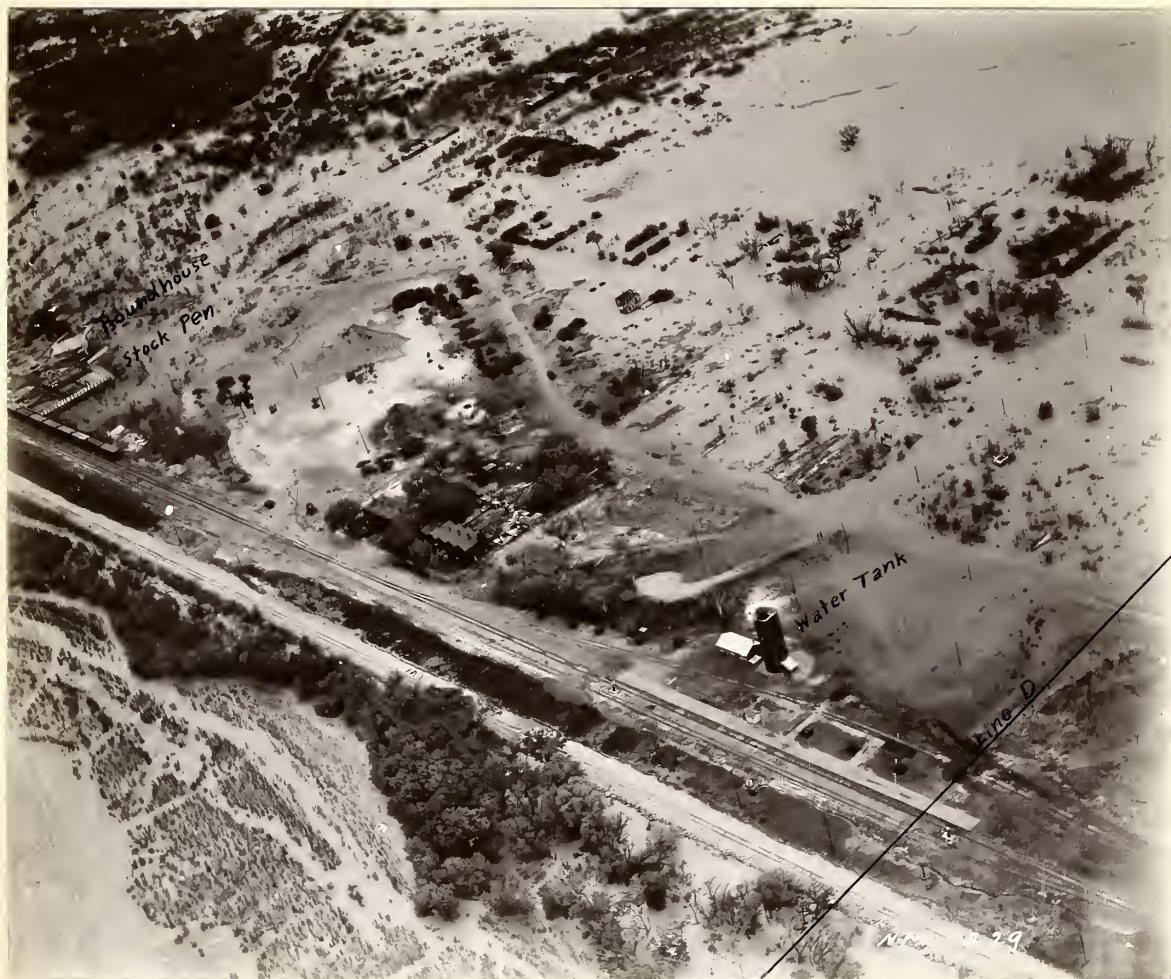
San Marcial Station, section headquarters, former roundhouse and dwellings surrounded by water. Looking southwest from near the highway bridge.

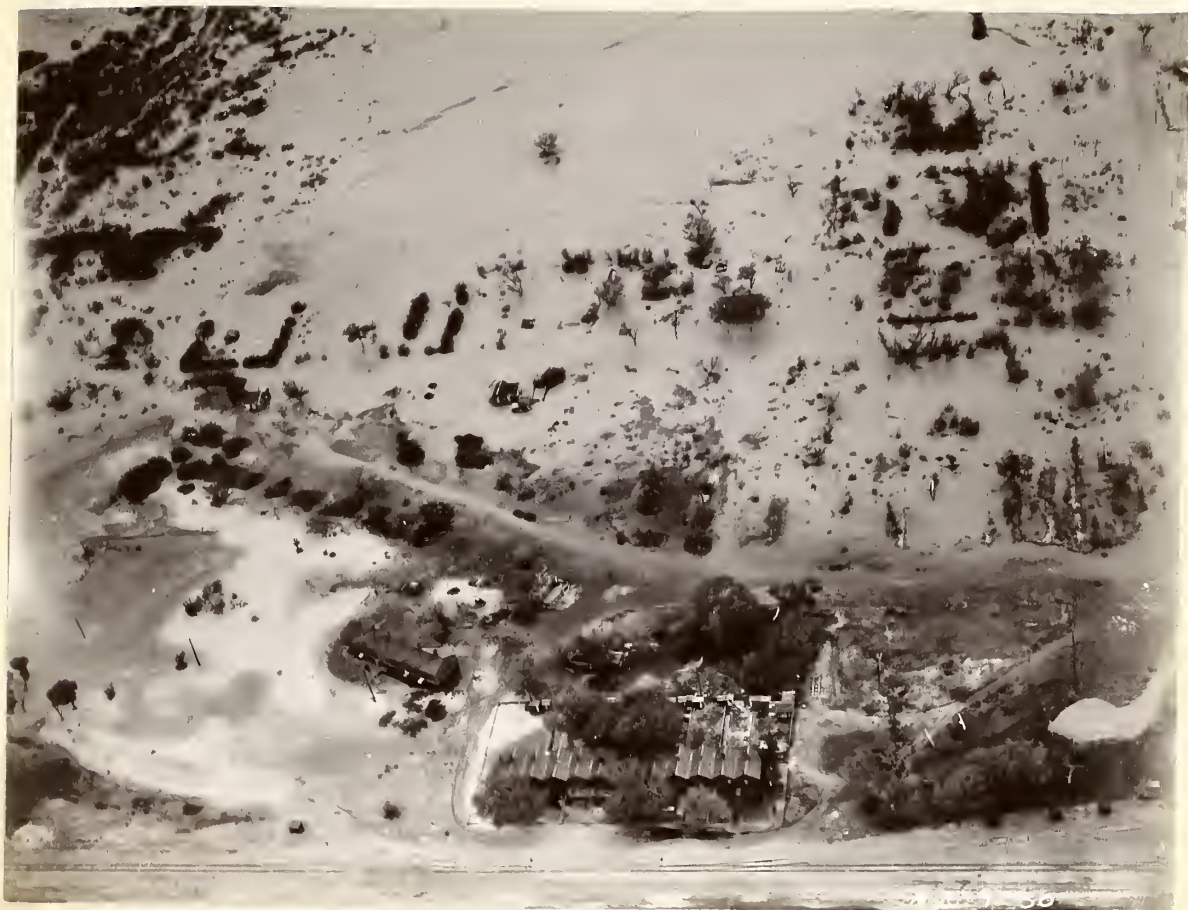
Inundated railroad section headquarters near San Marcial. Looking west from over the embankment. These section crew dwellings were flooded in 1929. The second stories until recently occupied are just above water.

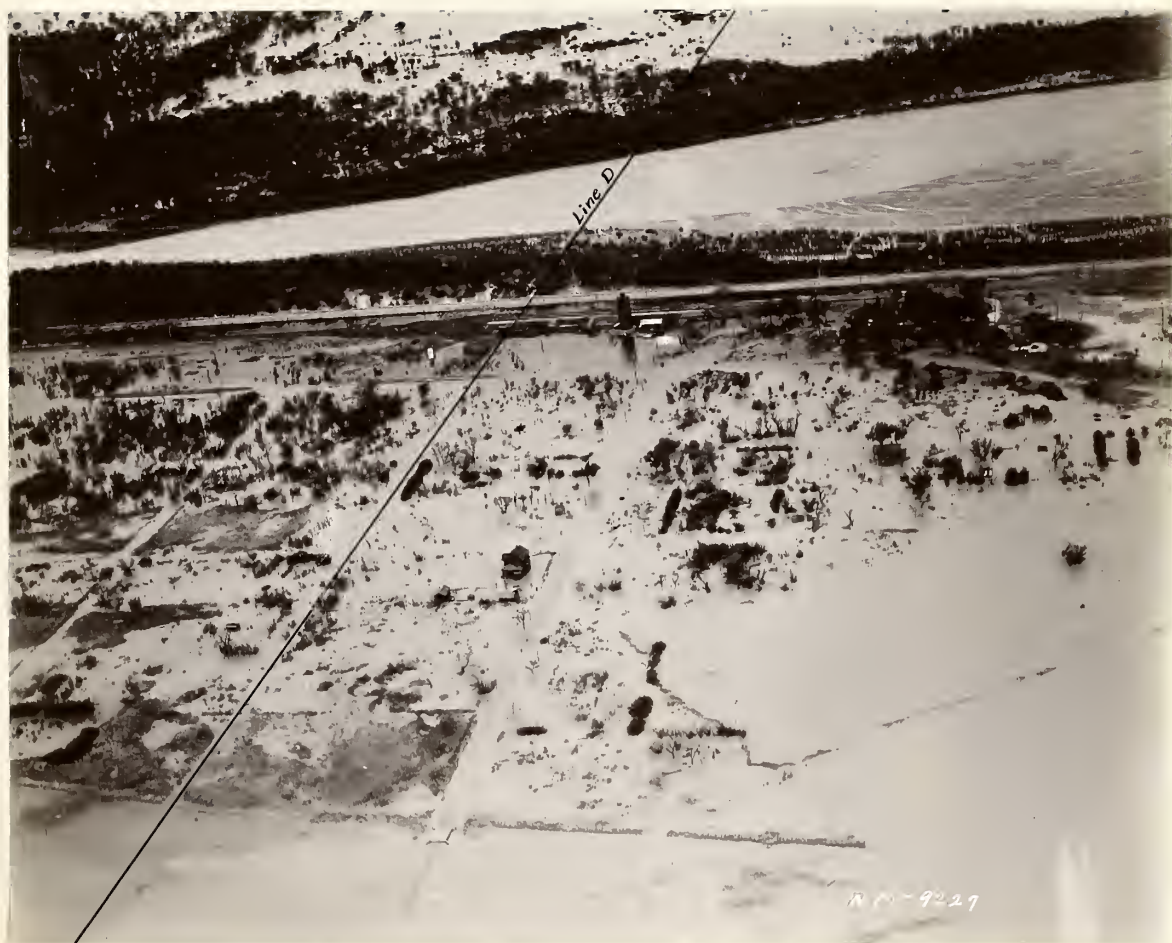
Inundated area, showing a flooded highway, residence and railroad works. Looking east from directly over San Marcial.

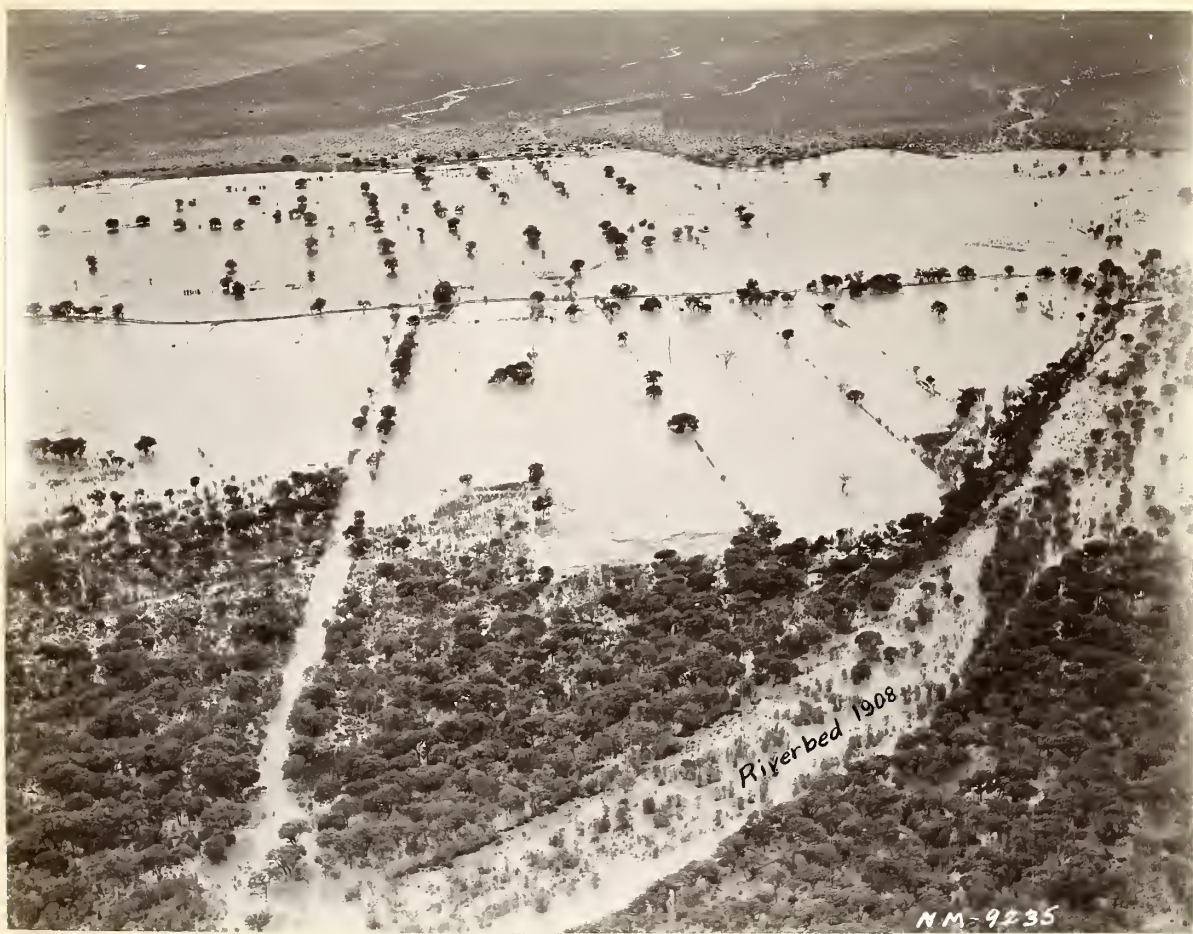
Inundated agricultural land just south of Val Verde. Looking east from below the highway bridge.

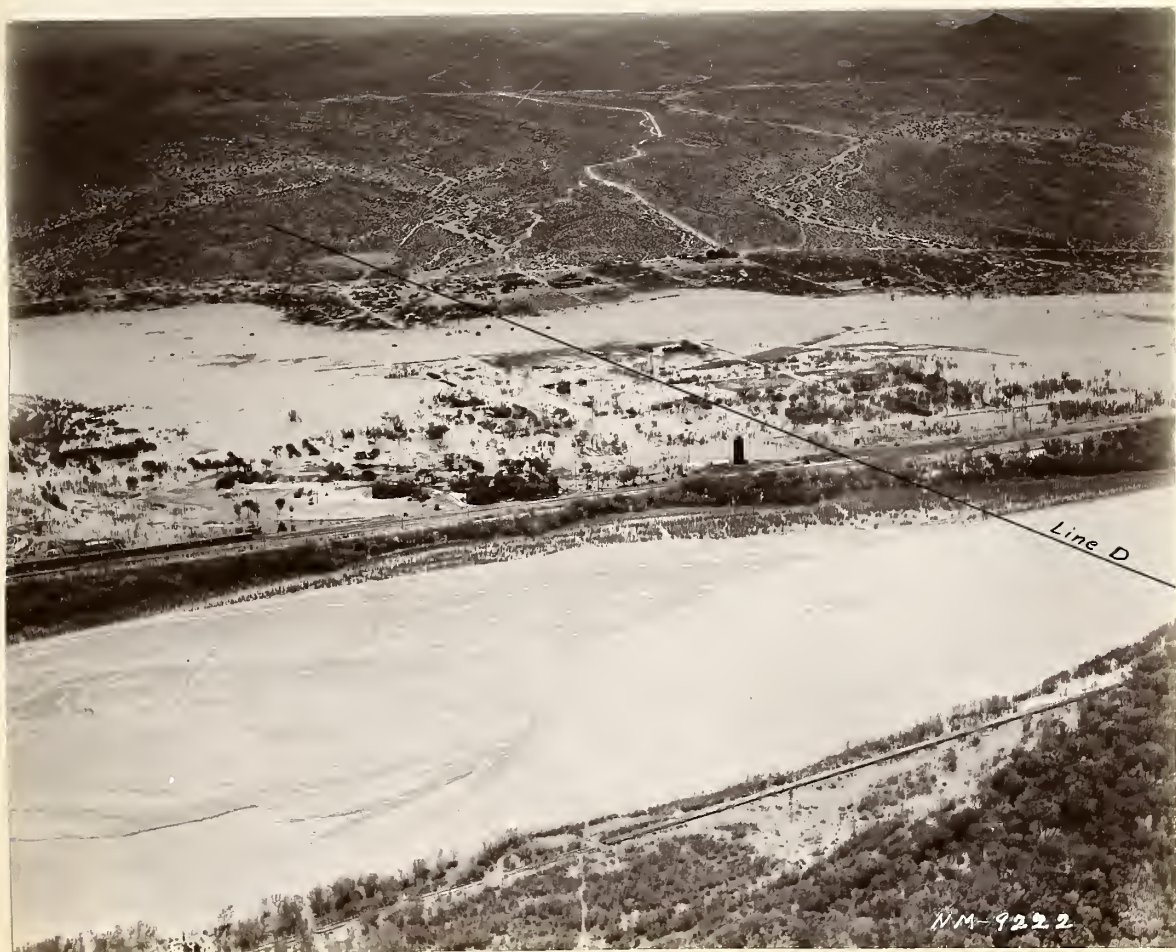
San Marcial Station and inundated lands between the railway and the town of San Geronimo. Looking northwest.

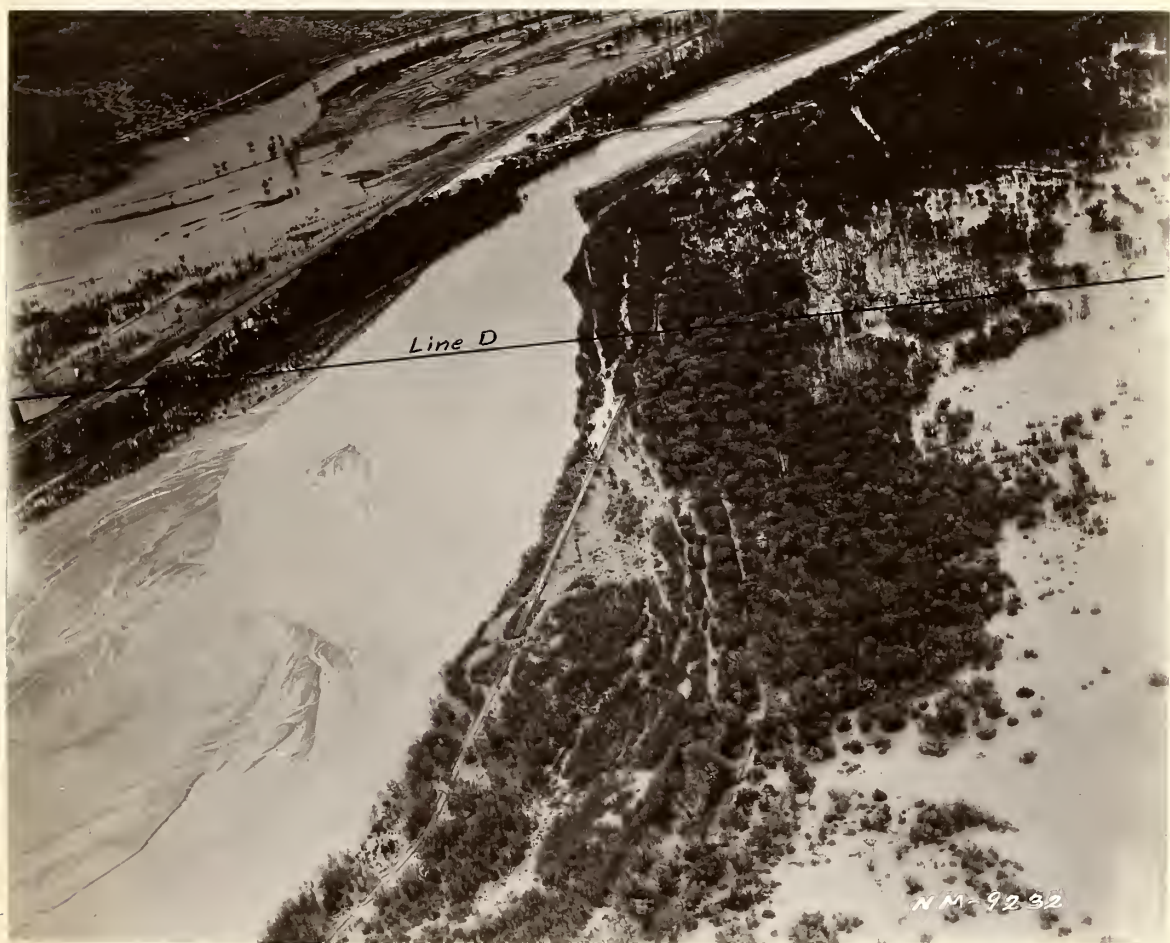
General view of the river just north of the Black Mesa showing the inundated bosque land on the Val Verde side on the right half of the picture . Breaks in the dike through which flood waters are draining are visible on this side. The highway bridge is visible in the upper center of the picture. Looking north.

An inspection was also made of the dike along the river. I was unable to get farther than just below Line R at which point three large breaks occurred, through which I estimated from 1200 to 1500 second feet of water were flowing east and northeasterly. That part of the dike which I traversed was in a very weakened condition.

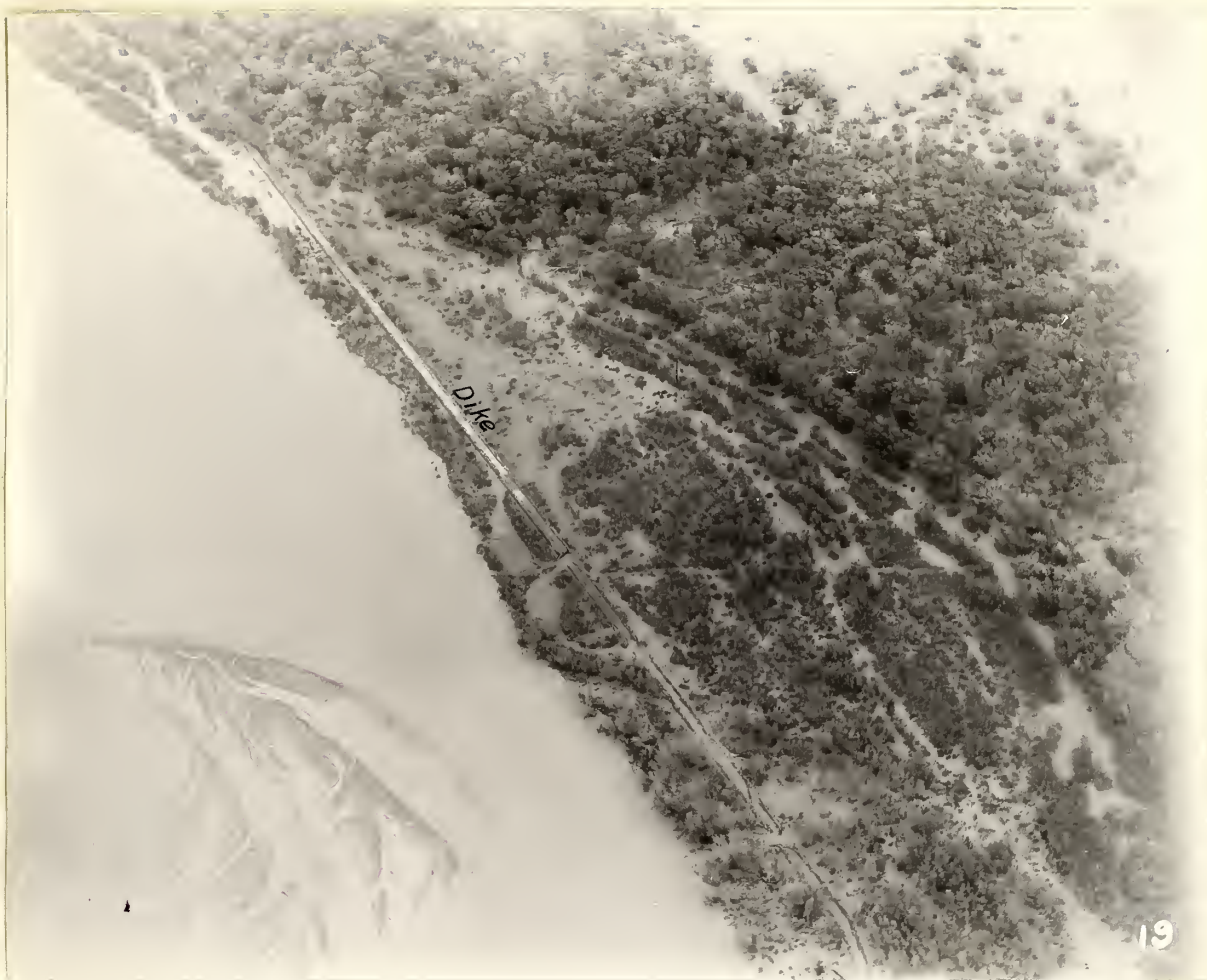
Dikes along the Val Verde side of the river showing breaks through which flood waters are pouring. Looking northeast from below the highway bridge.

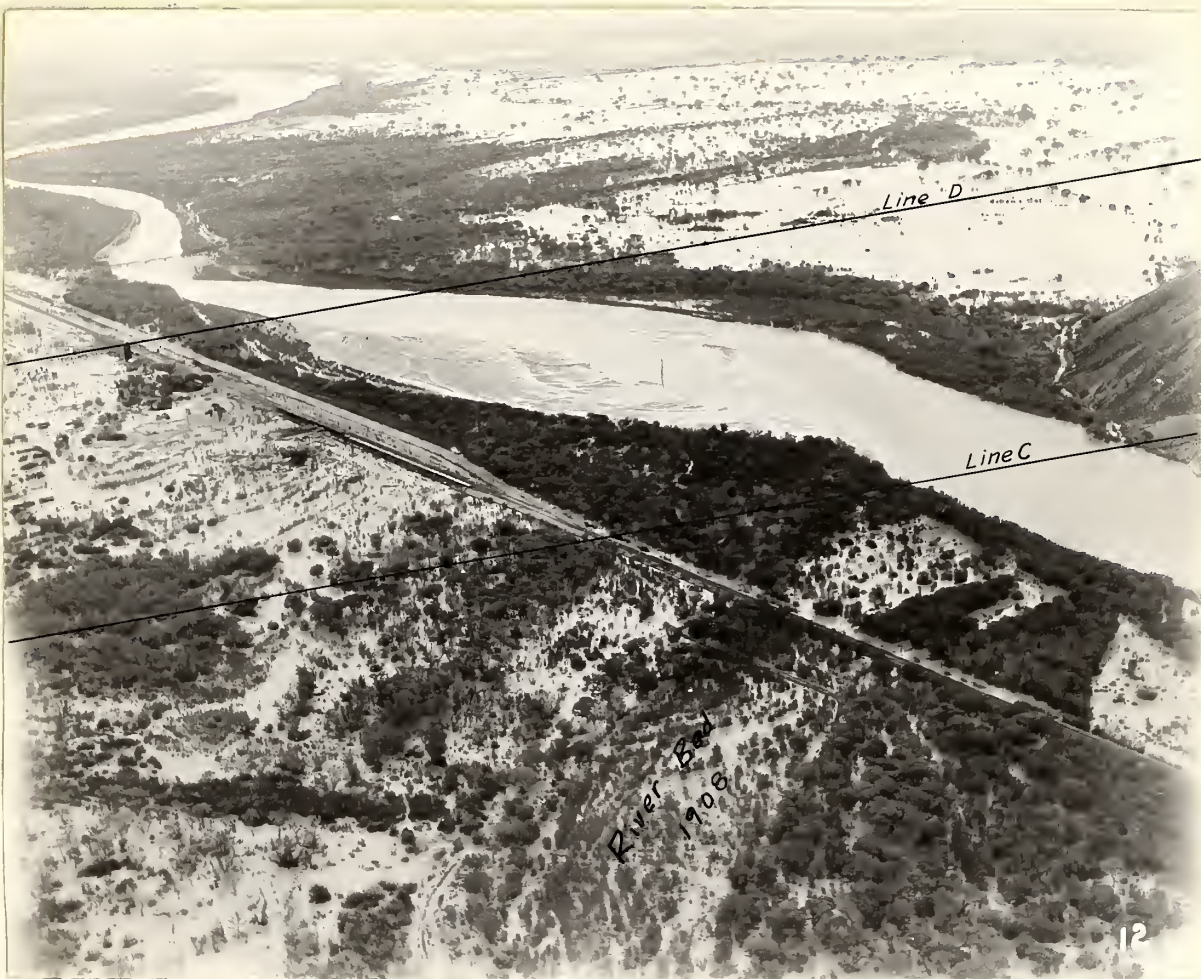
Inundated area south of the San Marcial Station. Also silt bars in the river exposed by receding waters. General view of a portion of the Val Verde area in the background. Looking northeast from Old Town.

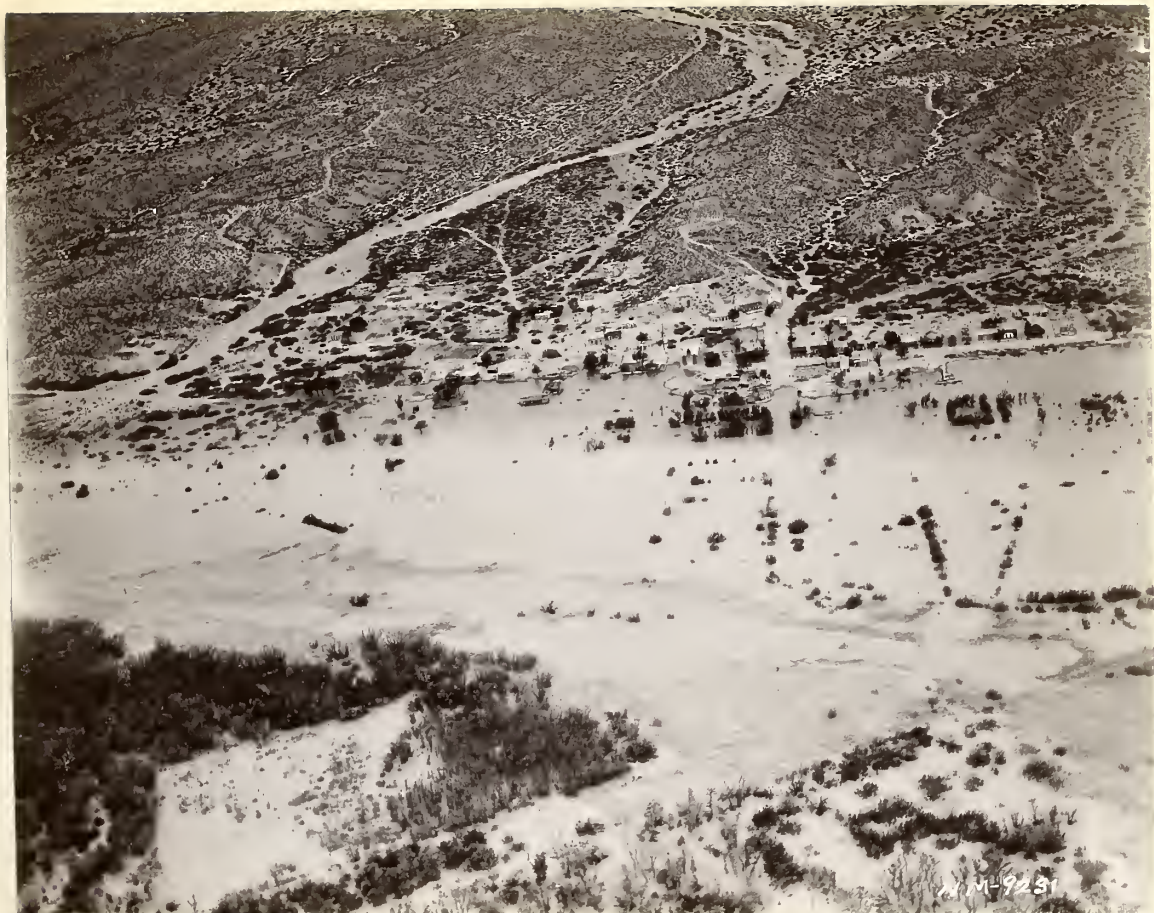
General view of the flooded area at Old San Marcial showing the inundated area between mesa and railroad. Looking west.

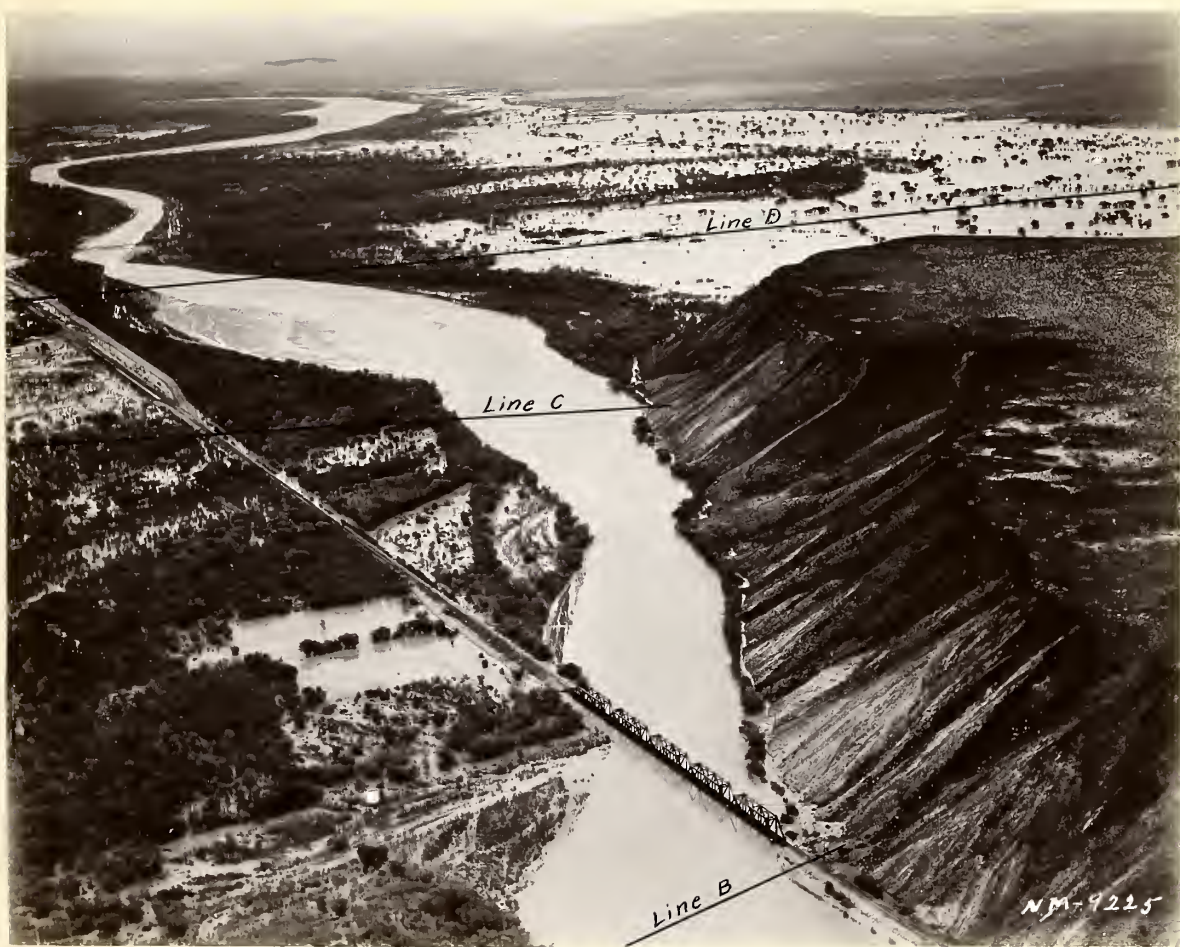
Railway bridge; showing alluvial cone formed just downstream from it. Backwater from the cone flowing towards San Marcial. Also shows general view of the Val Verde flooded area and silt bars in the river near the San Marcial Station being exposed by receding water. Looking upstream from just west of the Black Mesa.

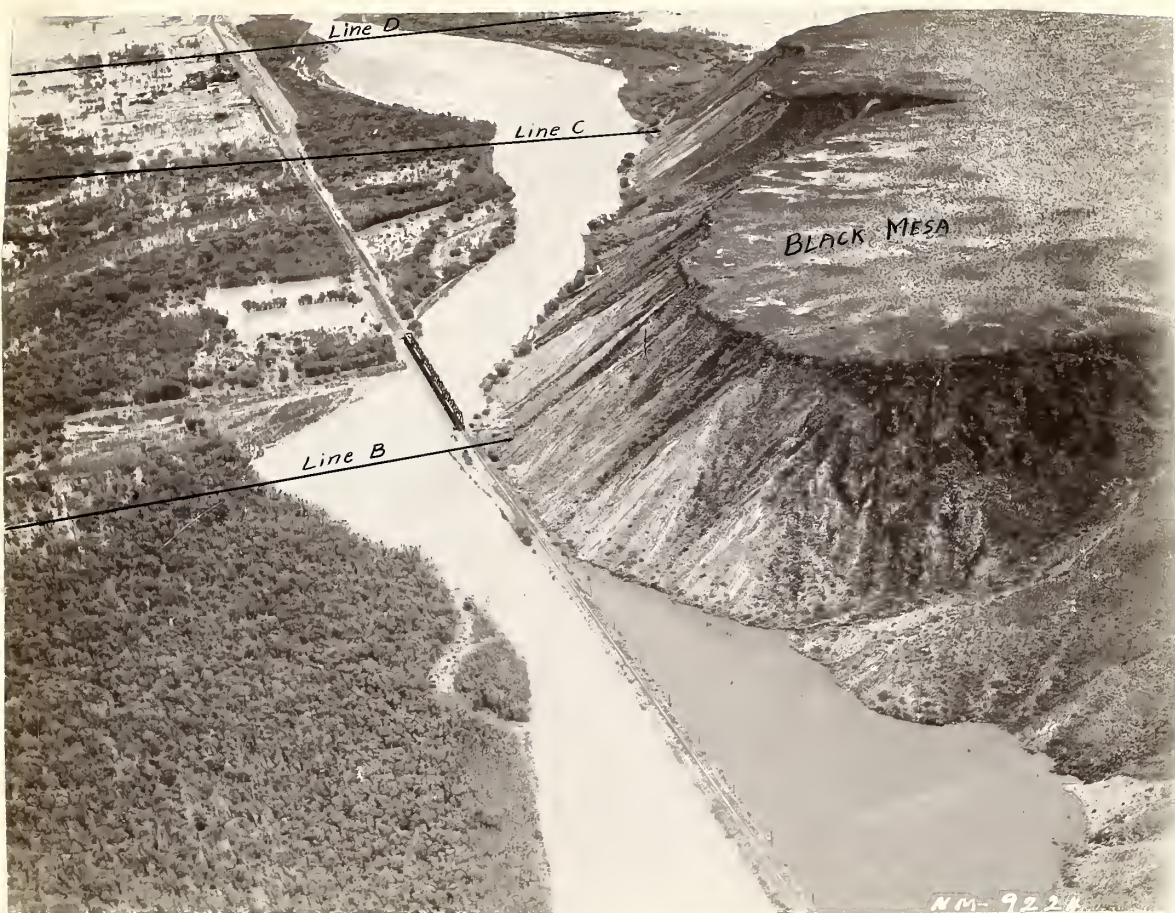
Railway bridge showing the bend in the river and backwater from it flowing towards San Marcial. Looking upstream from south of the Black Mesa. Water in right foreground is seep water.

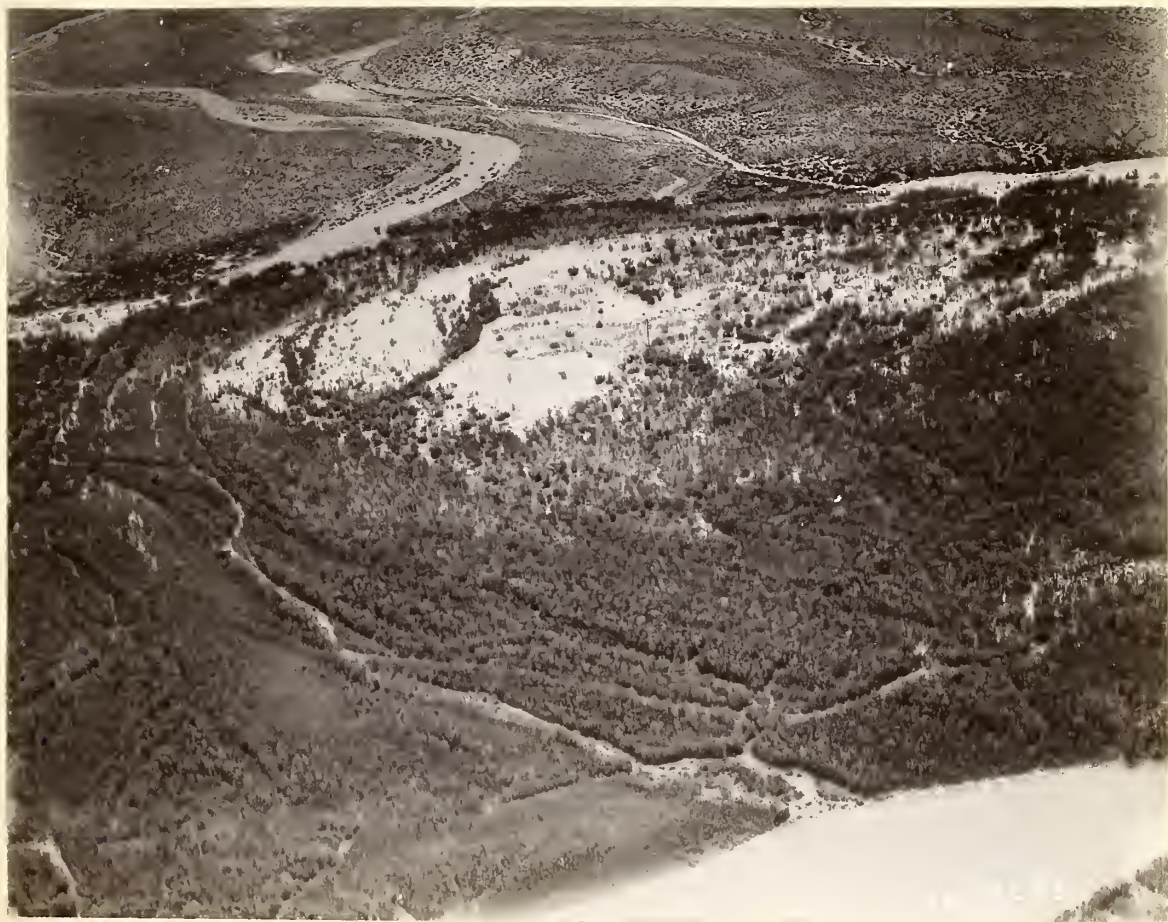
Bosque area on west side of river downstream from the railway bridge, looking northwest. Showing water running towards mesa on the left and from Old Town in right background.

I noticed a peculiar condition on the upper side of the bridge. The surface water seemed to be comparatively clear yet boils which would bring sand and silt to near the surface occurred due to the obstruction of the bridge piers. This was something that I had never seen before at this site or any other place. It was evident that the deposition of silt below the railway bridge was causing a rise in the stream channel and water surface. A large percentage of the water flowing under the bridge was still flowing northwesterly towards San Marcial.

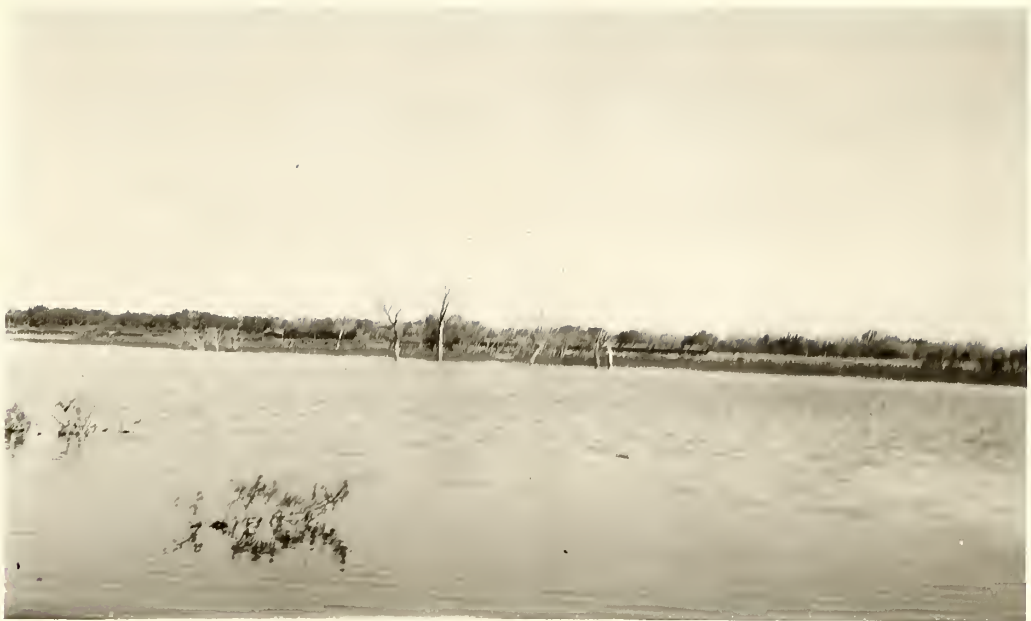
Rio Grande Valley. Line F. Looking easterly from Station 17 / 40.
